Lancair Legacy Canopy Safety Issue

Valin Thorn

Legacy Project N114TF

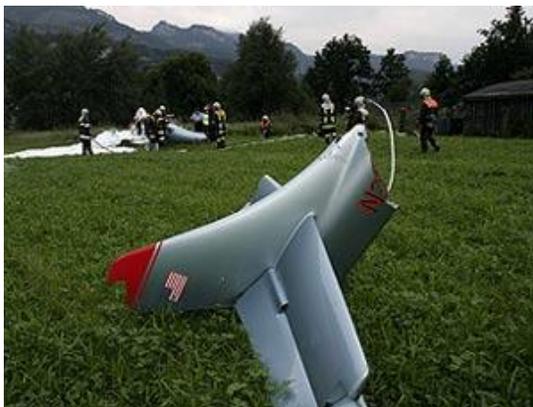
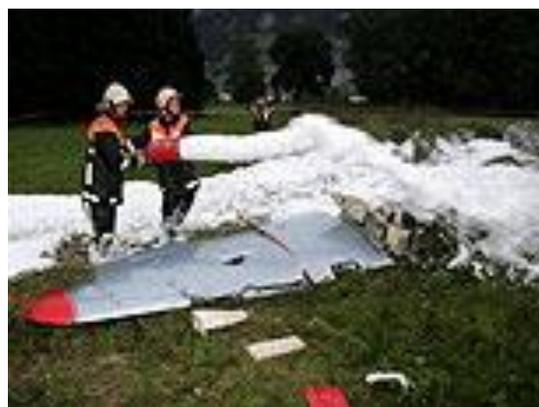
The plane lost the wings on the very hard touch down. The fuselage broke behind the seat and ejected Wolfgang out of the plane. It was a muddy soft grass field and the engine was buried in the mud.

N345MW Wreckage

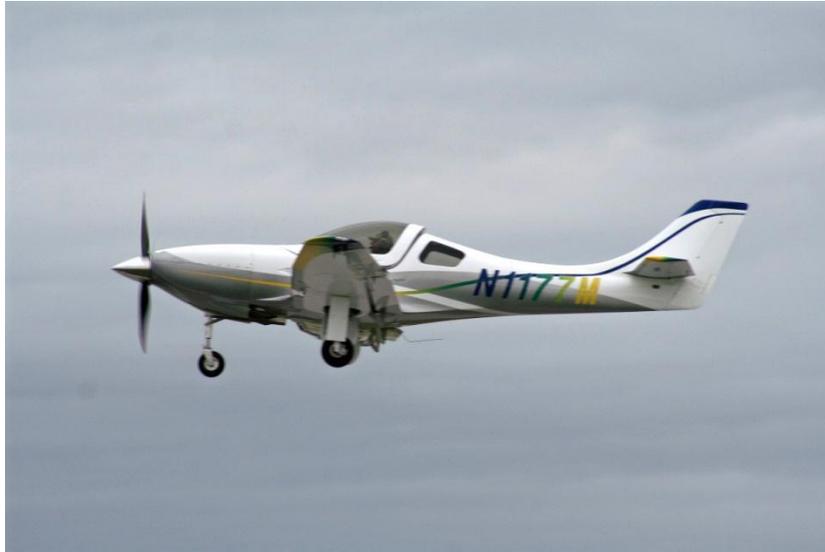
According to witnesses, the pilot was observed having difficulty closing the canopy on the airplane prior to takeoff. During the takeoff climb, a witness said he saw the cockpit canopy moving and believed the pilot was pushing it up and down about 6 to 12 inches. Another witness stated that shortly after takeoff, the engine lost power and the airplane continued straight and level. Another witness stated that she saw a plastic bag float down from the sky shortly after the airplane passed over her location. The bag contained several of the airplane's documents inside of it. The airplane then nosed down about 40 degrees and the left wing dropped as the airplane stalled and collided with the ground. A post-crash fire ensued which consumed part of the engine and the majority of the airframe, including the canopy latching system. Examination of the available wreckage did not reveal any evidence of pre-impact failures or malfunctions. The pilot Gerard Schkolnik, (Aeronautical Engineer, Private, ASEL) age 44, was fatally injured.

Photo of N1177M on takeoff before crash, note open canopy

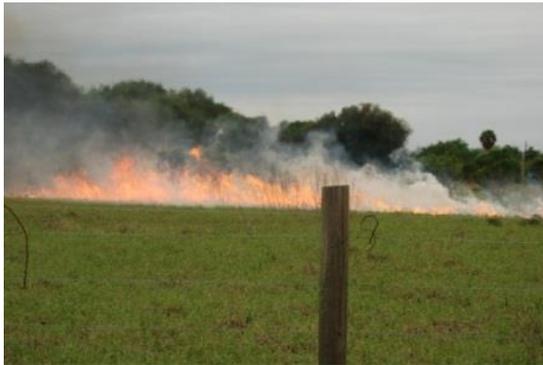
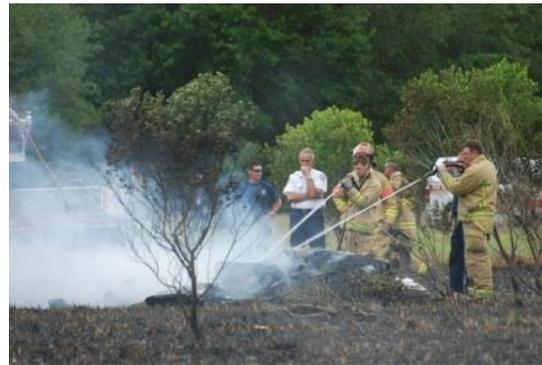
N1177M crash site, wreckage (Photos: The Ledger.com)

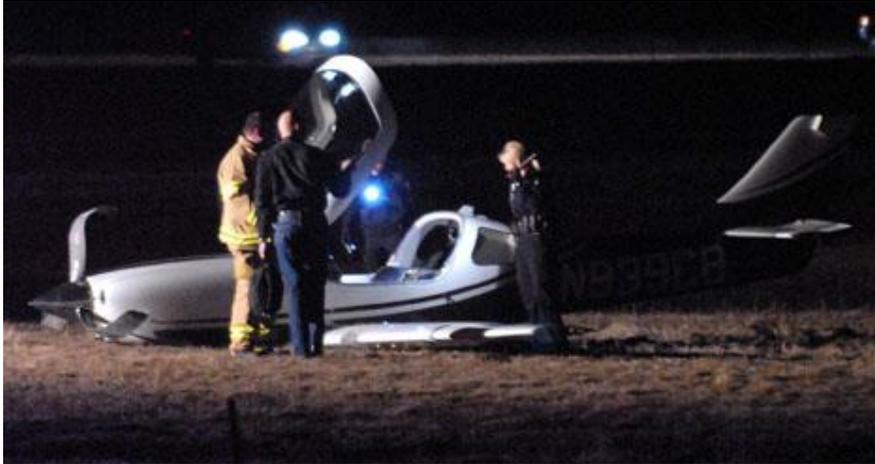
David said on final approach, the canopy opened so far that the runway could not be seen straight ahead. When looking to the side for reference, the wind blast was so high that it blew his eye glasses off his face. On landing, his Legacy's landing gear sheared off, skidded through fence posts, with significant damage.

N939CB After Open Canopy Crash Landing

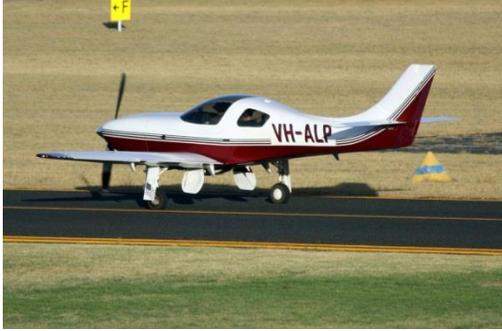
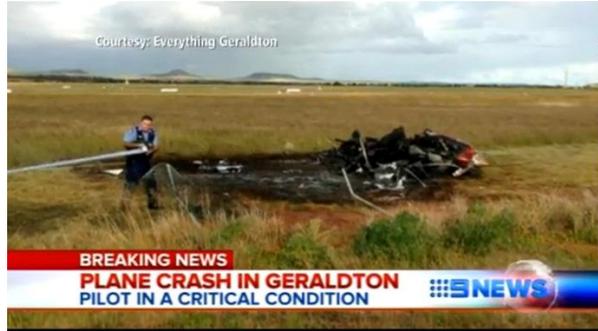
The pilot appeared to be maneuvering for a landing on runway 08 but the aircraft wheels hit a road curb short of the airport perimeter. The aircraft then collided with the perimeter fence and became entangled as it overturned. Shortly after, an intense fire engulfed the aircraft.

VH-ALP Photo and Crash Site

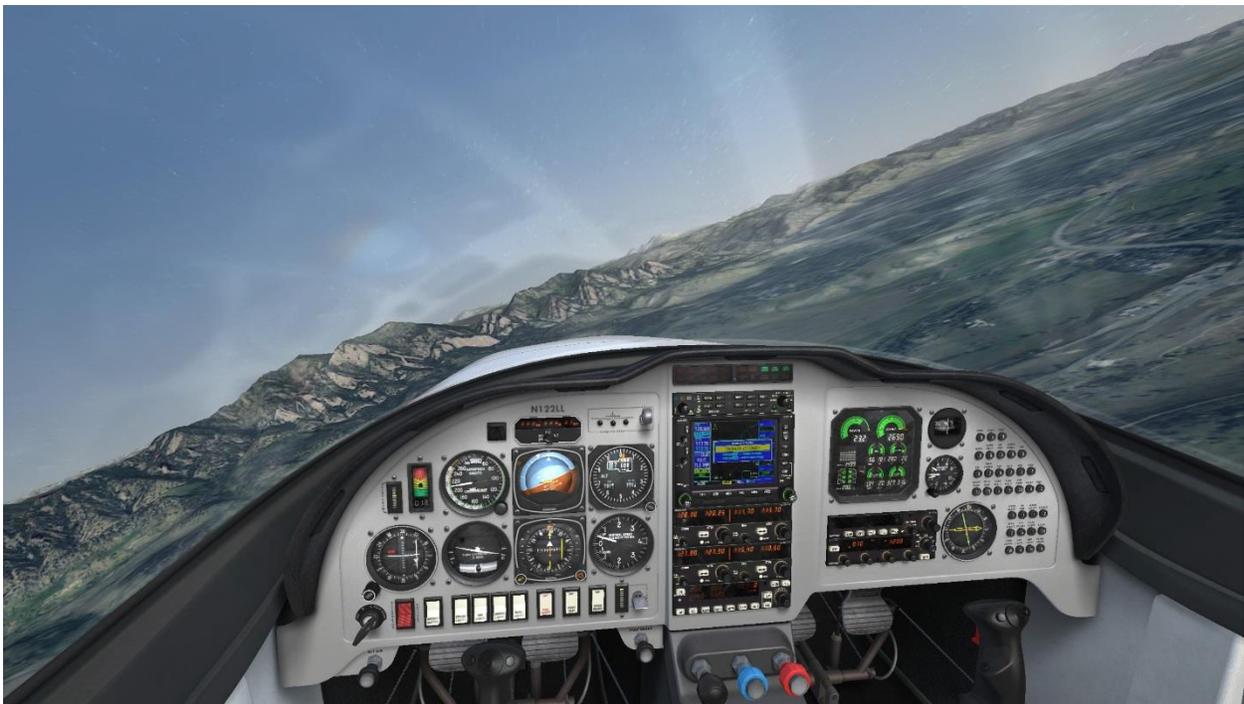
The illustration below shows an example sight picture of the visual attitude reference for the Legacy.

Legacy cockpit sight picture, visual pitch attitude reference

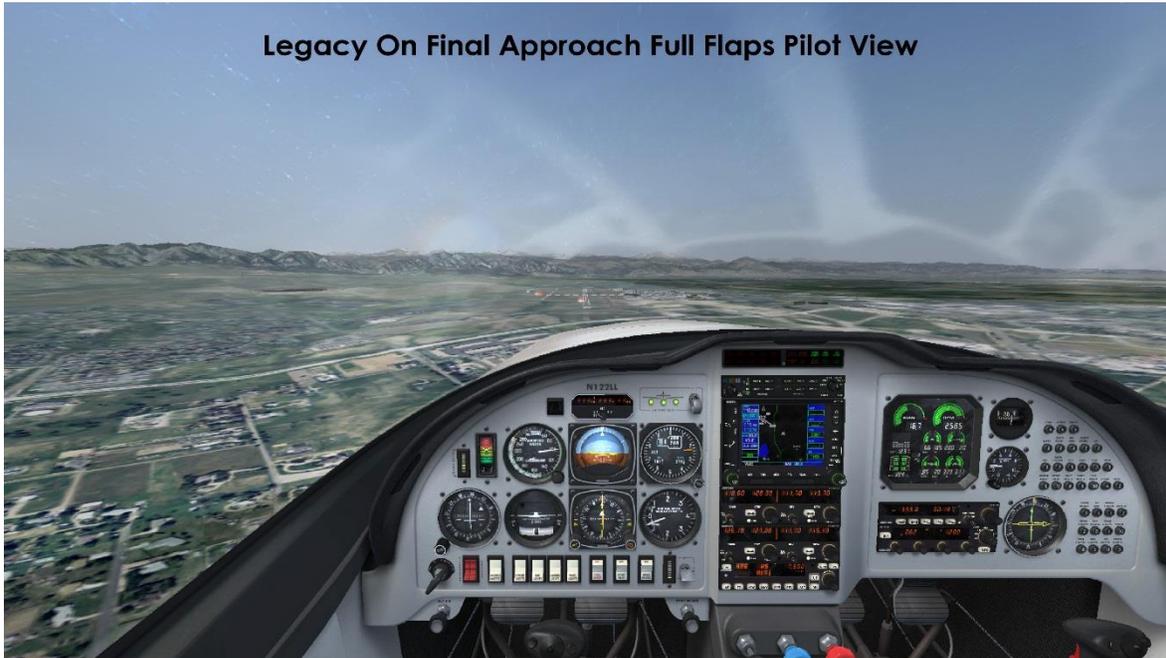
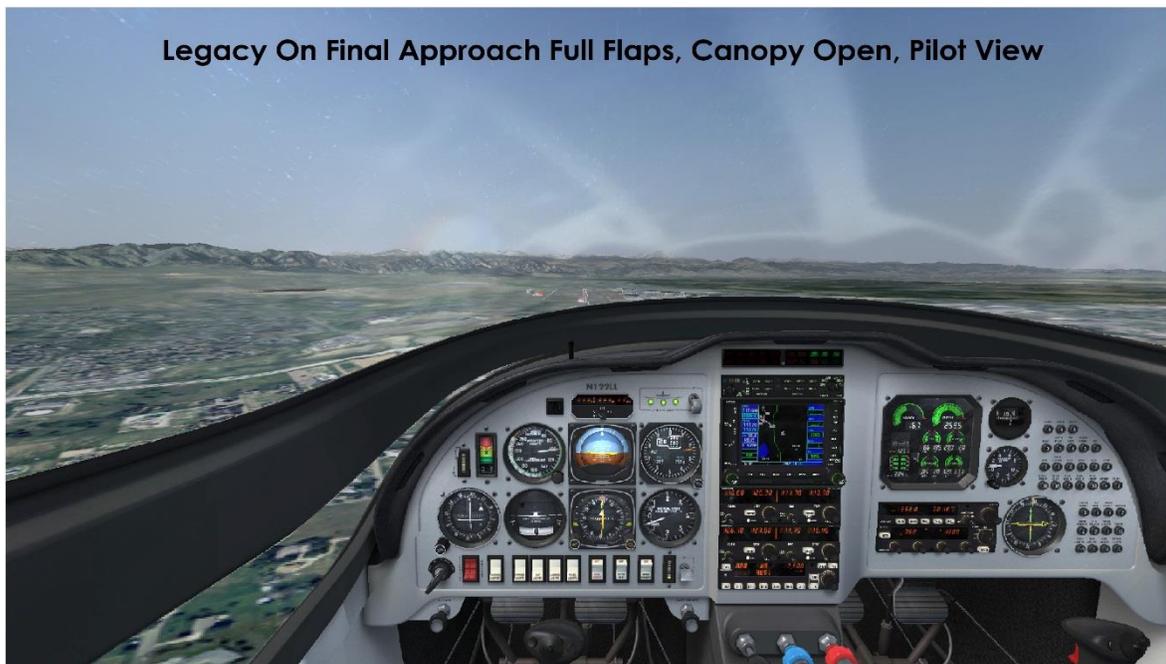
To understand this dynamic, it's helpful to examine either of the images in the last two rows where the second row from the bottom is the Legacy on final approach with the canopy closed and the bottom images are the exact same airplane location and flight attitude but the canopy is open several inches. The images with the flaps extended are shown in larger scale below. The left photo column is with no flaps and the right is with full flaps. As the canopy moves up, the view of the nose is lost, the instrument panel glare shield reference is obscured, and the canopy frame location can make it seem as if the airplane has been pitched nose down significantly.

Legacy view on final approach with canopy closed and partially open

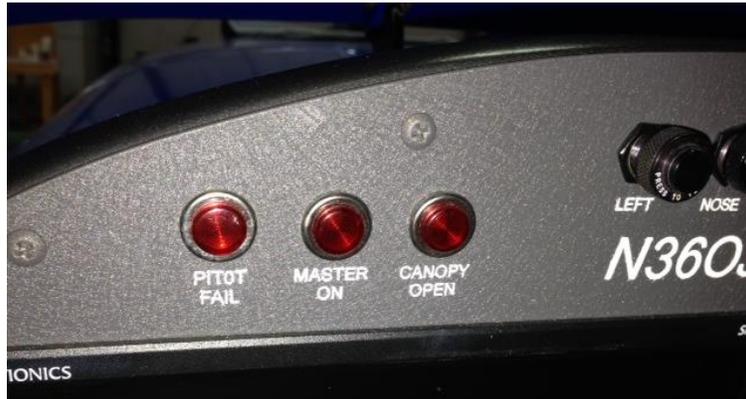
Example Canopy Unsafe Warning Light in Jack Addison's Lancair 360

The risk of takeoff without the canopy latched can be reduced with a prominent annunciator on the instrument panel warning the canopy is in an unsafe configuration – not down and latched and/or with the condition wired to an Electronic Flight Instrumentation System (EFIS) for alerting.

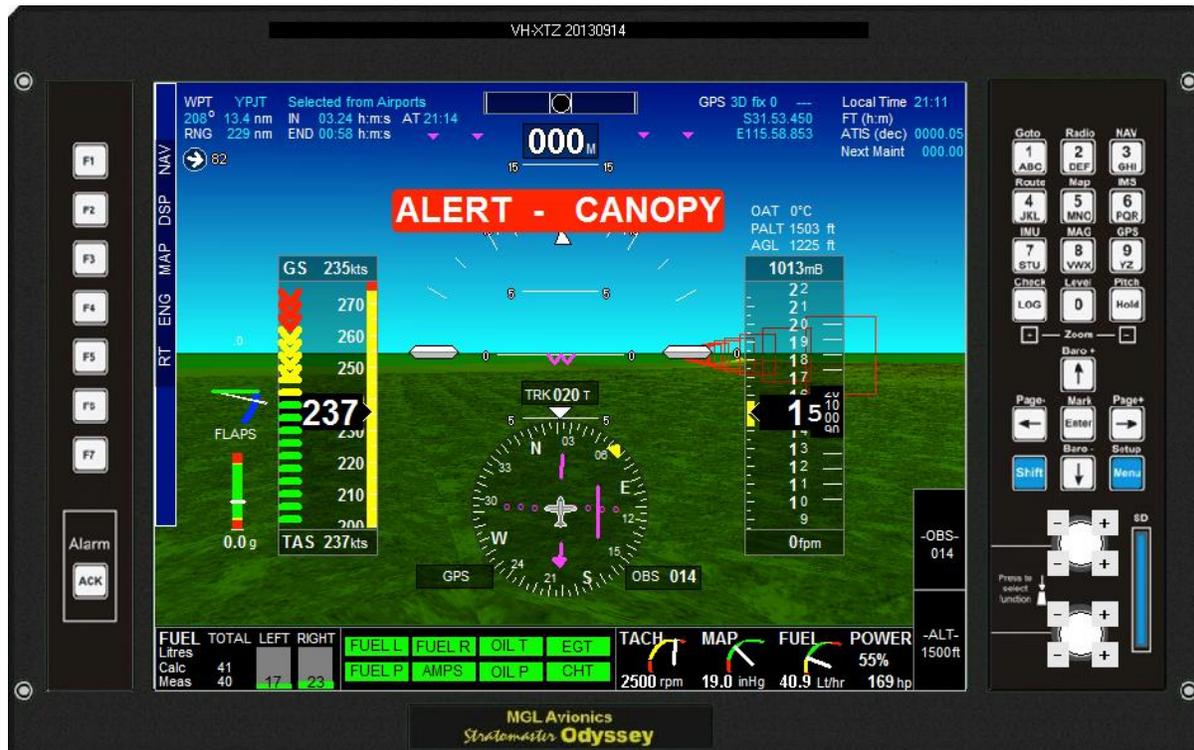
Example EFIS Warning in John Smith's and Gary Weeks' Lancair Legacys (VH-XTZ and VH-ZYA)

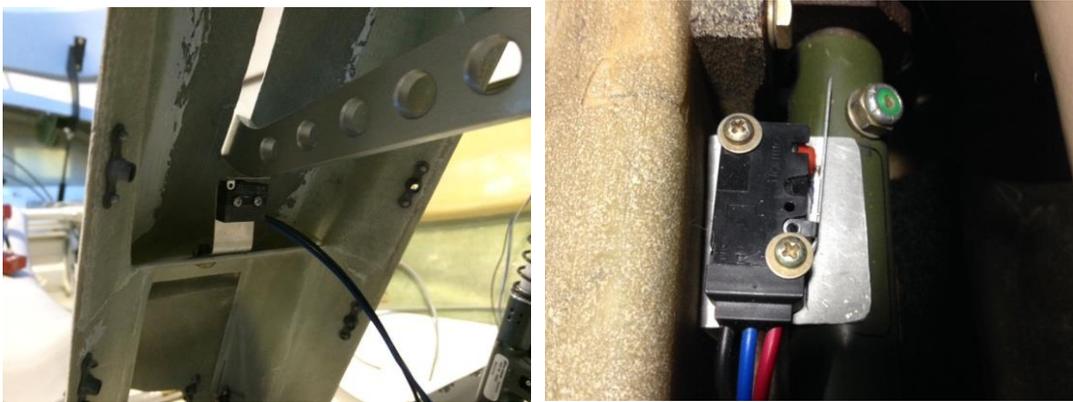
The following photos show examples of micro switch mounting to measure canopy and canopy latch positions. The micro switch is positioned so that the canopy alignment guide depresses the switch. The micro switch mounting shown in these photos are for a Legacy with air ducting below the canopy opening and modifications to the cockpit structure around the canopy latch lever arm. Exact mounting for a stock/unmodified Legacy will be slightly different – but the principle is the same.

Canopy latching lever micro switch mounting examples

The micro switches shown can be wired for “Normally Open (NO)” or “Normally Closed (NC)” switching determined by the wires used. The black wire is the Common line, blue is Normally Open and grey is Normally Closed. The Normally Closed switch position means that when the switch lever arm is not pressed, the switch is closed/completes the electrical connection and allows current to flow. In the example shown, the circuit should be connected to the black and grey (NC) wires. With both switches wired through their NC wires, when their lever arms are depressed, the switches will open, cutting off electrical current to the canopy unsafe annunciator light and the EFIS system. Make sure you adjust the micro switches so they BOTH act within the last 1 to 2 mm or 1/16th inch of movement.

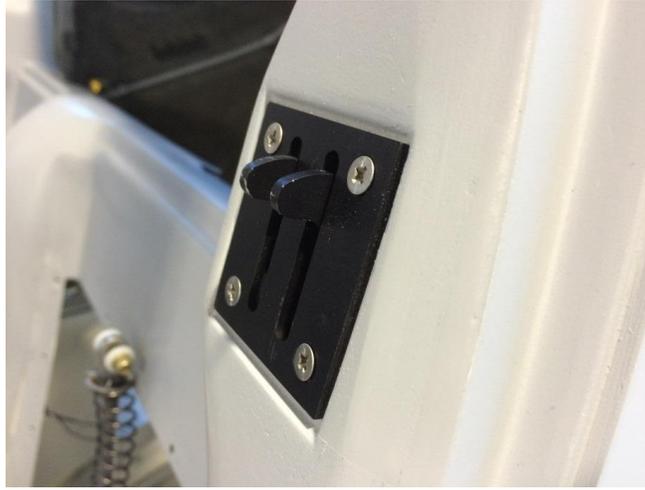
The Canopy Latch Mechanism Modification requires the upper lever stop be moved lower so the canopy latching claws remain extended $7/16$ " when the canopy lever is in the fully unlatched position.

Photo of Canopy Latch Claws Modified to Remain Partially Extended When In Full Canopy Release Position

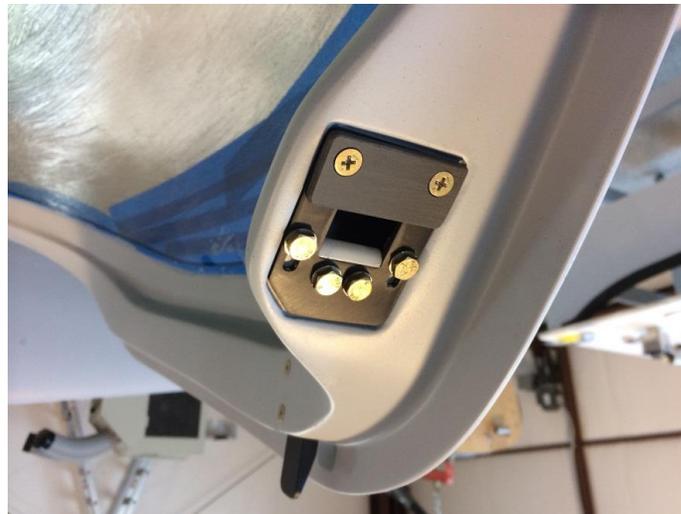
The canopy latching striker plates require installation of 1" x 2" pieces of 1/8" thick Nylon or ABS. The top AN3 hex head bolts are replaced with MS24694 – S54, (10-32) countersunk screws to secure the new "canopy lift plates".

Photo of Canopy Striker Modified with Lift Plate Installed

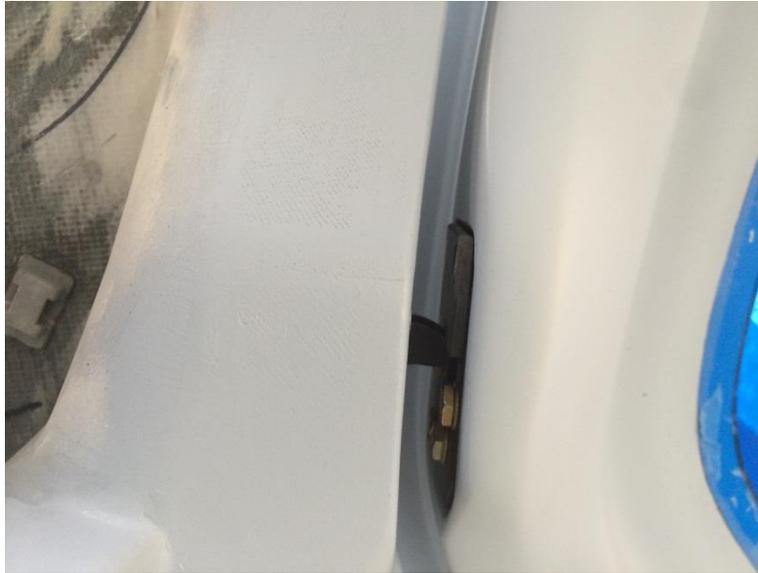
Photo Showing Claws and Striker Plate with Canopy Propped Open by Latch Mod
